**PROGRESSIVE REHABILITATION  
AND CLOSURE PLAN  
VULCAN COAL MINE  
Tenure number: ML700060**

**DECEMBER 2021**

Prepared for: Department of Environment and Science  
Prepared by: Mining and Energy Technical Services Pty Ltd  
EA holder: Queensland Coking Coal Pty Ltd and QLD Coal Aust. No 1 Pty Ltd  
Document ID: 00280099-033  
Version: 03  
Date of Submission: 6 December 2021

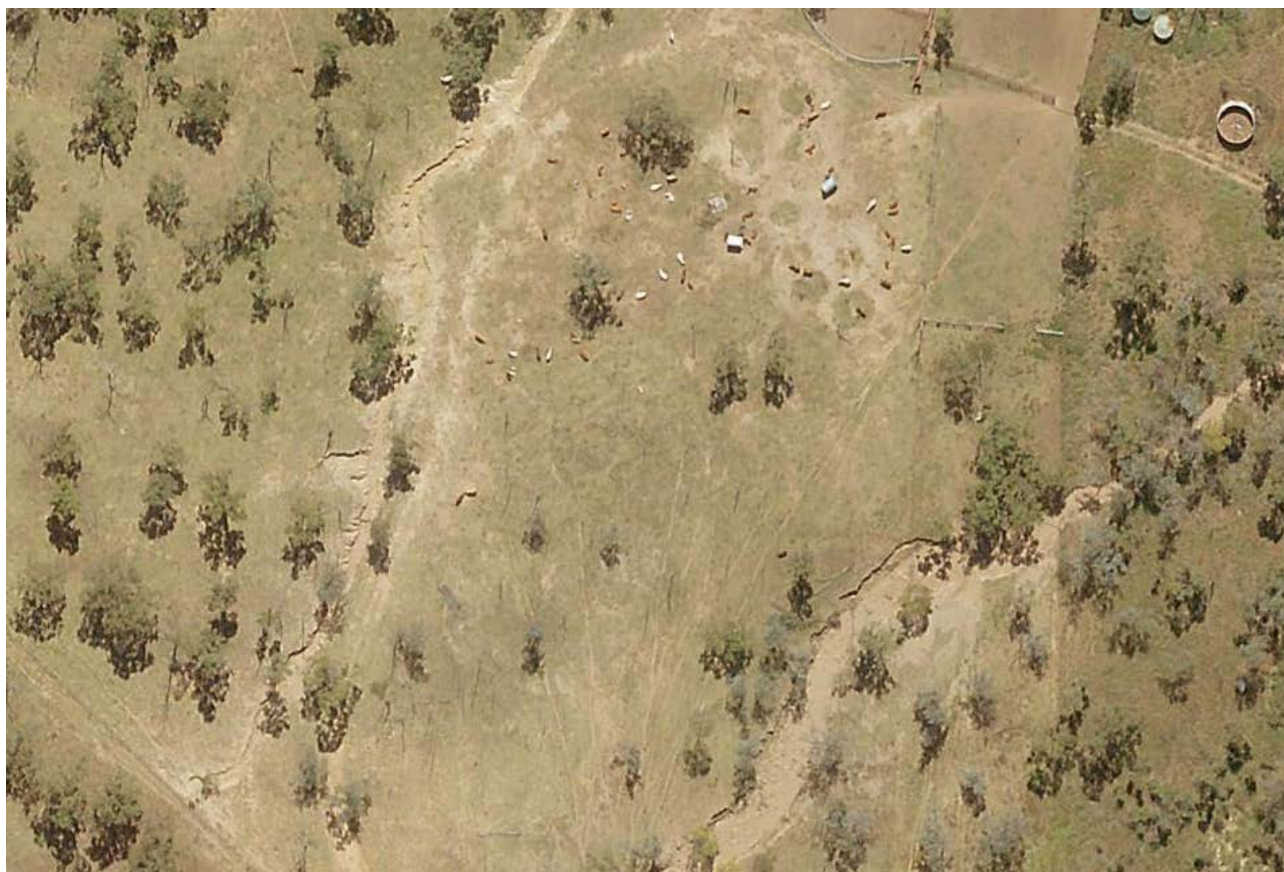
Figure 1-10 Extensive gully erosion in heavily grazed portions of the ML

All soil units contained within the ML are sandy-textured with poor water- and nutrient-holding capacity (AARC 2020). This causes them to support a relatively modest grass cover (usually 20-25%, as assessed in the late wet season: METServe 2020). Furthermore, while topsoils in all local soil management units are relatively stable, subsoils in the most widespread unit (Limpopo) are dispersive and prone to erosion (AARC 2021). Consequently, the land is predisposed to ongoing stability issues in its pre-mining state, and gully erosion is widespread along minor drainage lines in the western half of the ML, where grazing intensity is highest (Figure 1-10).

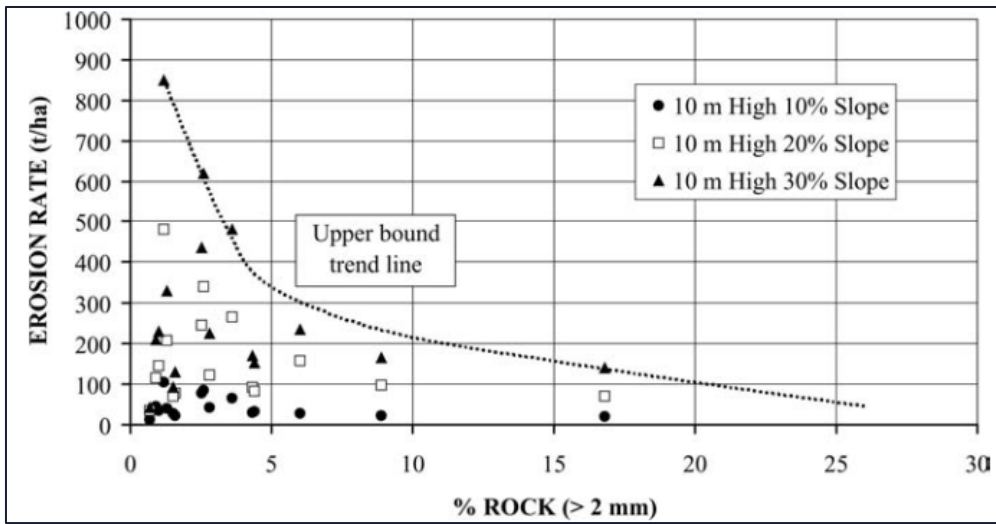
Studies in Queensland demonstrated that any gradient exceeding 3.5%, if not protected by some sort of cover, will erode under average rainfall conditions, and extreme rainfall can erode bare slopes greater than 0.35% (Williams 2001). However, rock or vegetation cover drastically reduces erosion rates (**Figure 6-13**).

Figure 6-11 Erosion rate versus percentage rock for Bowen Basin soil materials (figure from Williams 2001)

In light of published data, the approximately 30% rock cover for slope gradients of 10-15% will provide sufficient protection for these slopes during periods of low vegetation cover (e.g., initial phase of rehabilitation, or following fire or drought). An additional vegetation cover of 10-20% (total groundcover of 40-50%) is expected to provide a highly stable landform in the long-term.

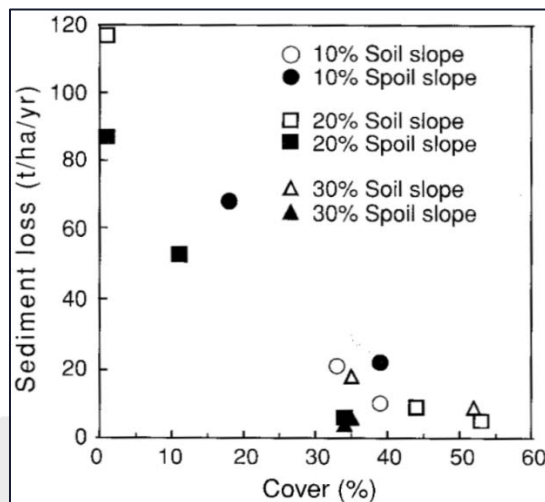
Figure 6-12 Annual sediment loss versus pasture cover on soil and spoil stockpiles at Oaky Creek (Figure from Carroll and Tucker 2000).

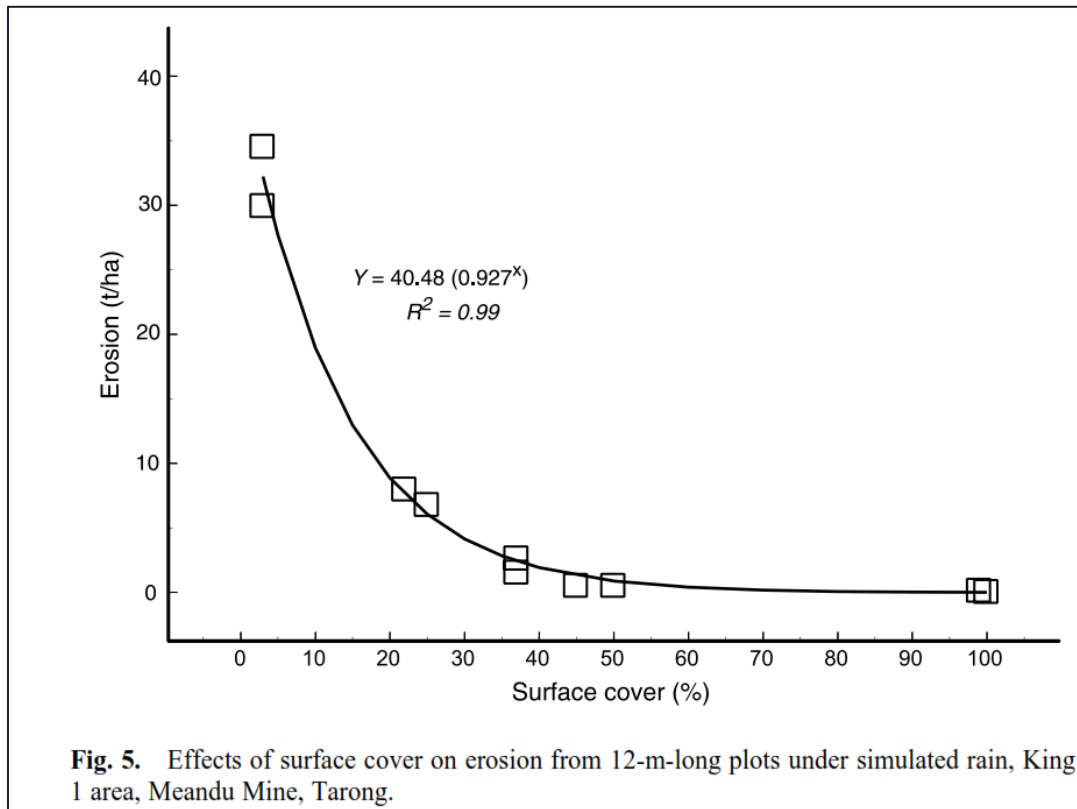
Figure 6-13 Effect of surface cover on erosion (12-m plots, 15% slope, simulated rain) at Tarong (Figure from Loch 2000).
