PROGRESSIVE REHABILITATION AND CLOSURE PLAN

VULCAN COAL MINE

DECEMBER 2021

Prepared for:	Department of Environment and Science
Prepared by:	Mining and Energy Technical Services Pty Ltd
EA holder:	Queensland Coking Coal Pty Ltd and QLD Coal Aust. No 1 Pty Ltd
Document ID:	00280099-033
Version:	03
Date of Submission:	6 December 2021

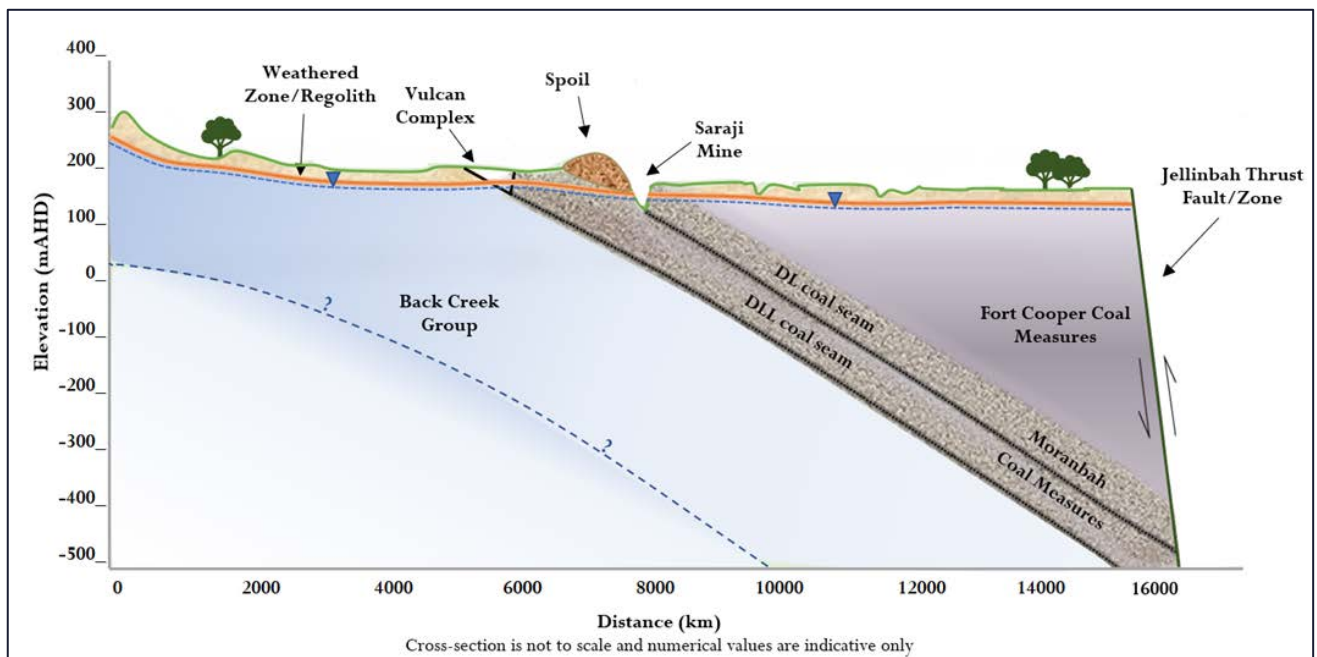
Figure 1-4 West-to-east conceptual geological model of the Mine area (hydrogeologist.com.au 2020)

A conceptual diagram of the main geological units is shown in **Figure 1-4**, and representative stratigraphy of the Mine area is shown in **Figure 1-5**.

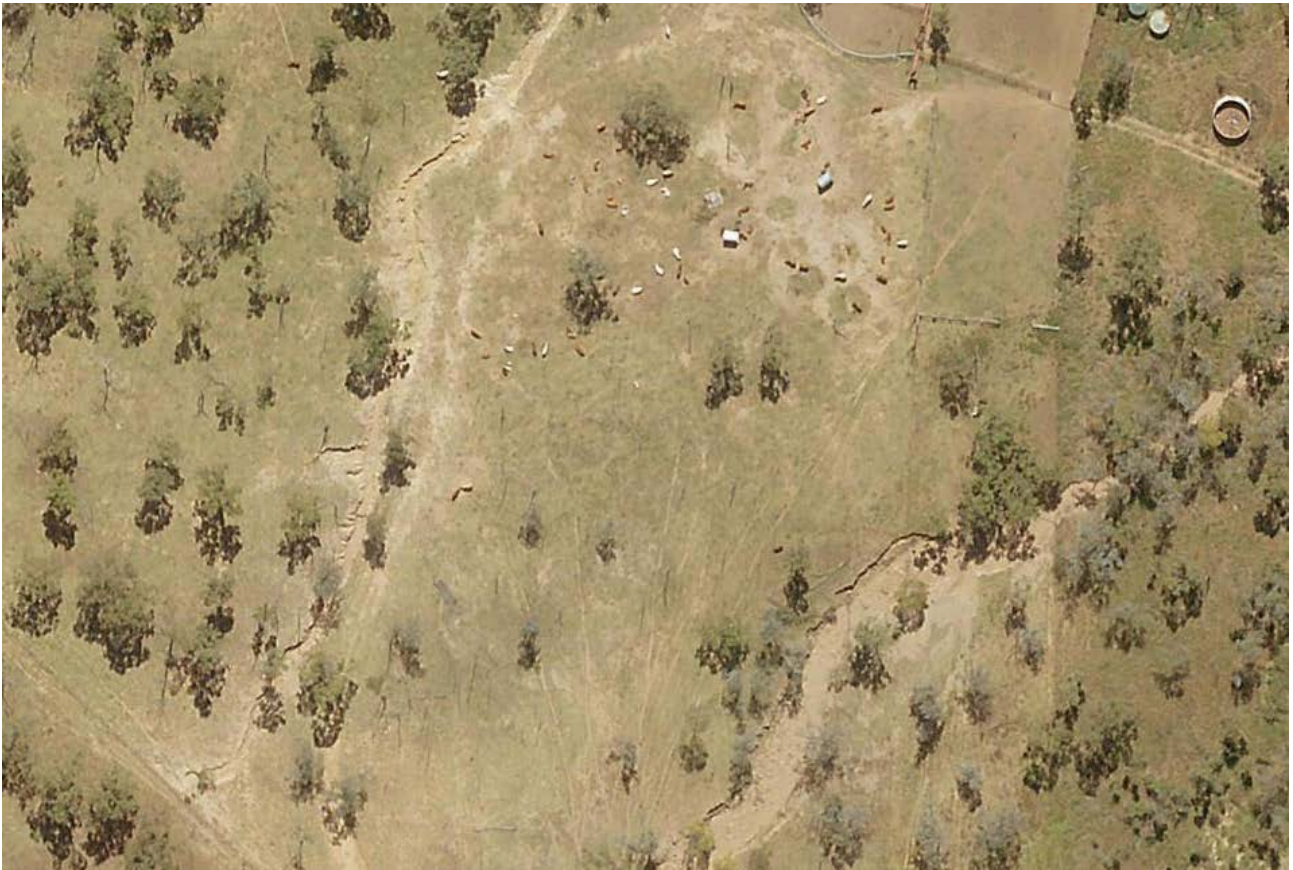
All soil units contained within the ML are sandy-textured with poor water- and nutrient-holding capacity (AARC 2020). This causes them to support a relatively modest grass cover (usually 20-25%, as assessed in the late wet season: METServe 2020). Furthermore, while topsoils in all local soil management units are relatively stable, subsoils in the most widespread unit (Limpopo) are dispersive and prone to erosion (AARC 2021). Consequently, the land is predisposed to ongoing stability issues in its pre-mining state, and gully erosion is widespread along minor drainage lines in the western half of the ML, where grazing intensity is highest (Figure 1-10).

Figure 1-10 Extensive gully erosion in heavily grazed portions of the ML
