VULCAN SOUTH SOIL AND LAND SUITABILITY ASSESSMENT

PREPARED FOR
METSERVE PTY LTD
MARCH 2022

Project Name:	Vulcan South
Report Title:	Soil and Land Suitability Assessment
Client:	METServe
Project Manager:	Stuart Ritchie

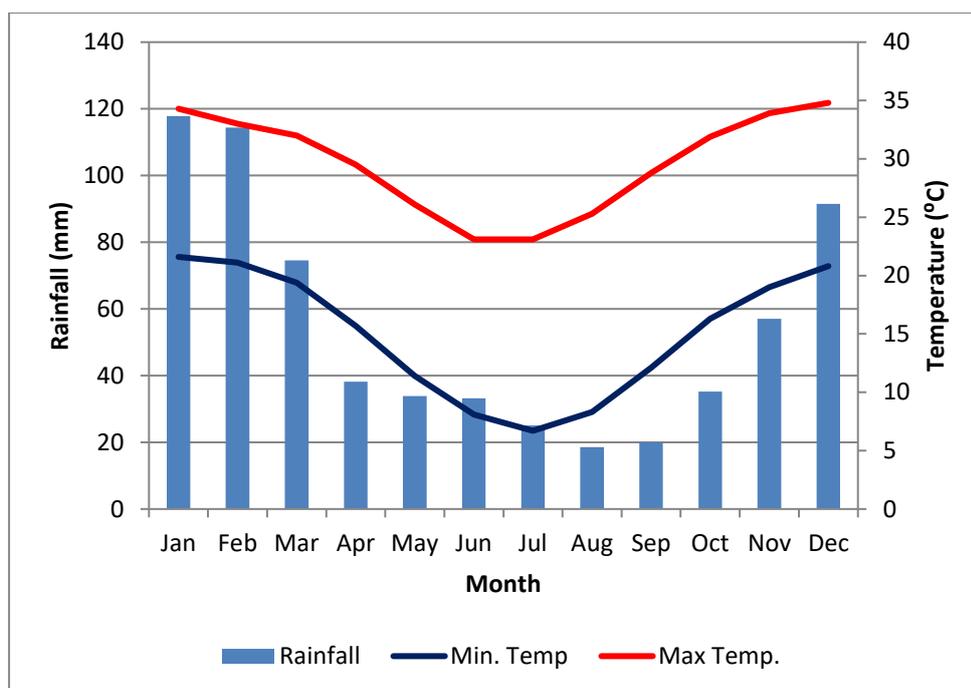
Figure 2: Climate statistics (Clermont Post Office)

The regional climate is classified as semi-arid, with characteristic hot summers and mild to warm winters. Climate statistics have been sourced from the Bureau of Meteorology for the Clermont Post Office, located approximately 77 km south-west of the Project. The data indicates average rainfall for the region to be approximately 665 mm with a characteristic wet season between November and March. Long term temperature statistics demonstrate that the average maximum daily temperature in summer is 34°C with overnight minimum temperatures averaging at 21°C. In winter, the average maximum temperature is 24°C with an average minimum temperature of 8°C (Bureau of Meteorology 2019).

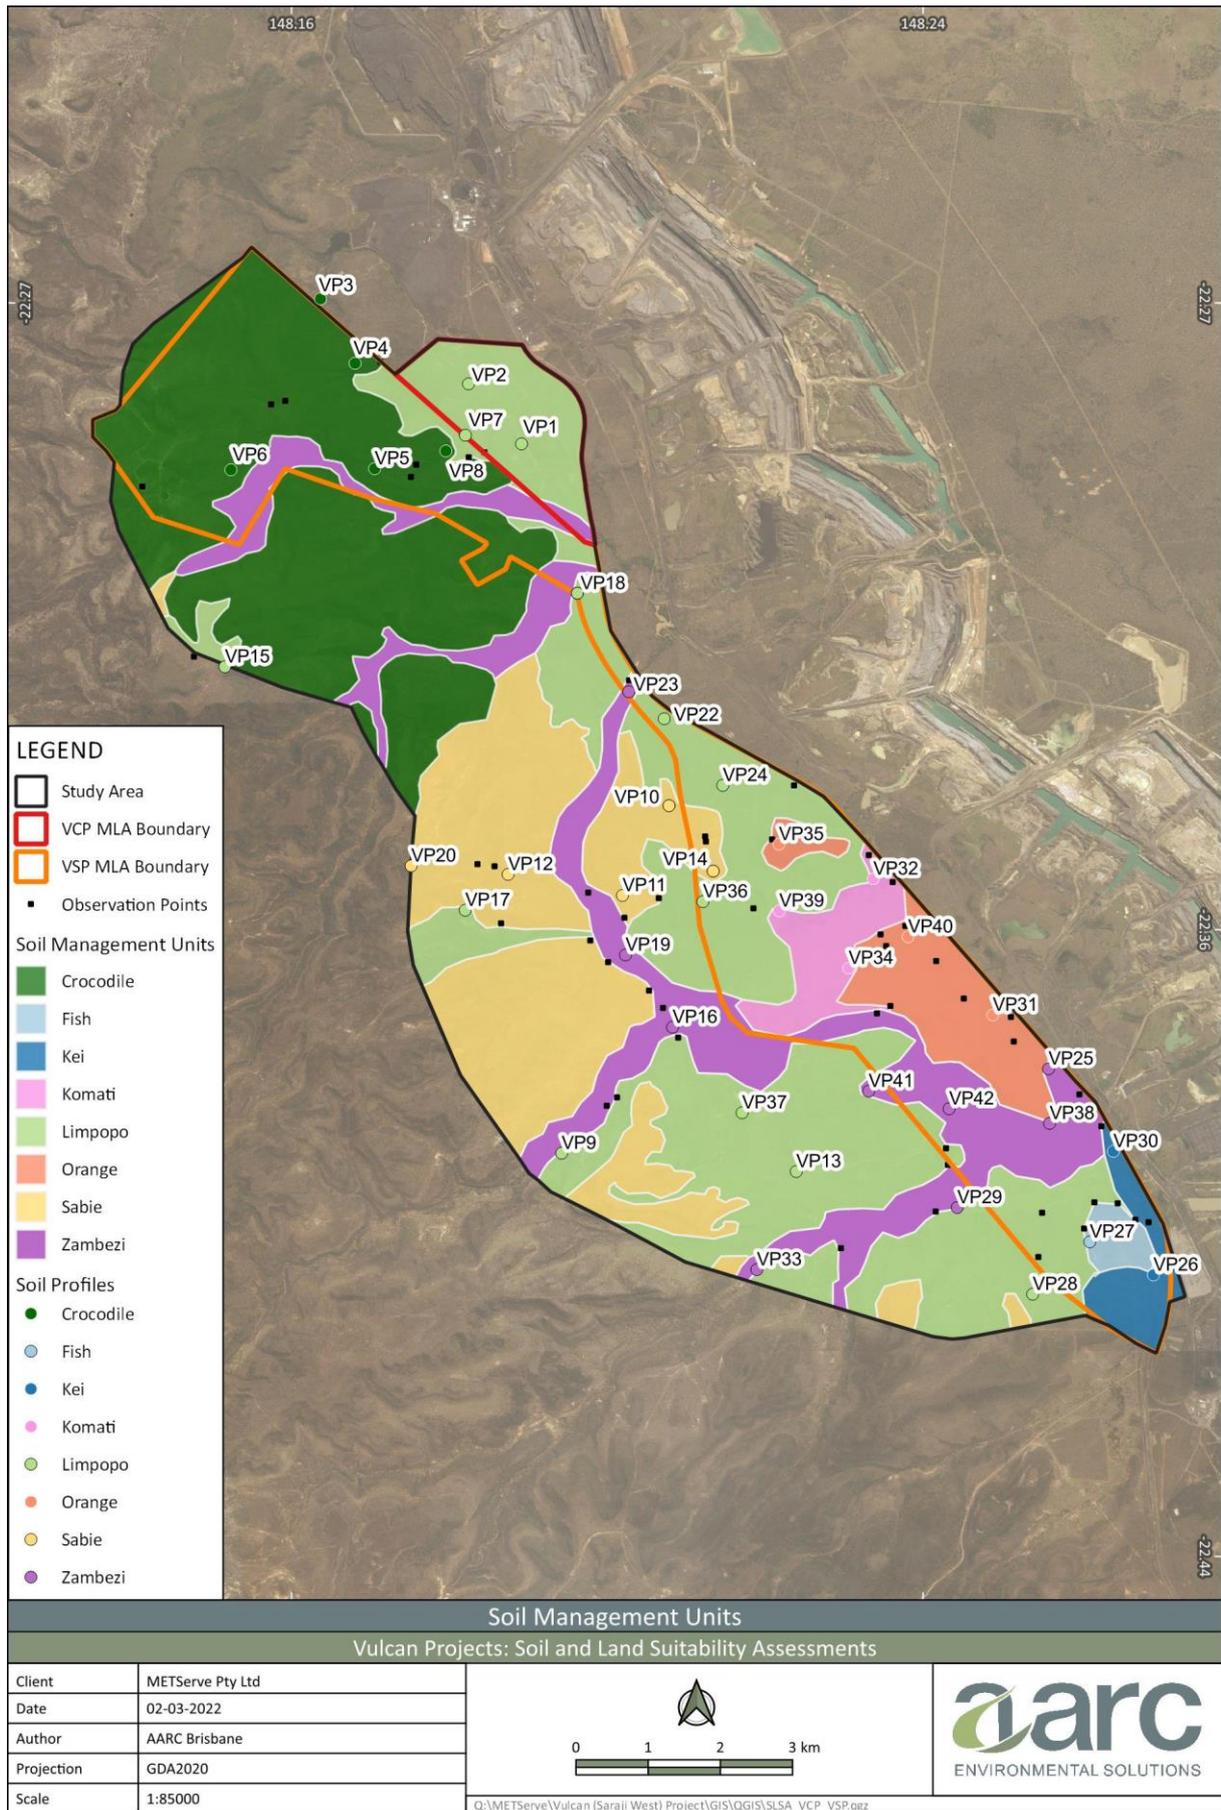
Figure 3: Distribution of soil management units (1:85,000)

SMU	Surface area (ha)	Per cent of Project area (%)
Crocodile	1,195	31.3
Fish	76	2.0
Kei	174	4.6
Komati	262	6.9
Limpopo	1,015	26.6
Orange	472	12.4
Sabie	47	1.2
Zambezi	577	15.0
Total Area	3,818	100

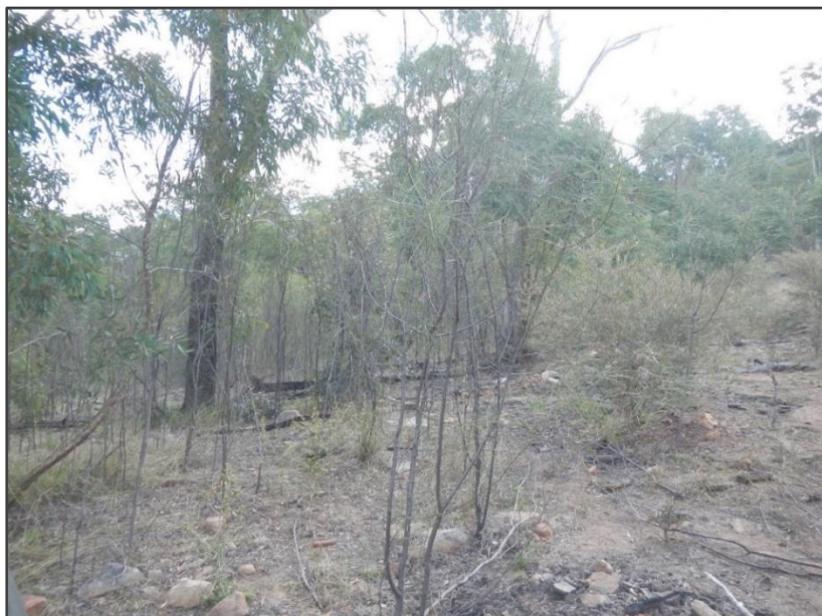
Figure 4: Crocodile SMU vegetation

A shallow rocky soil unit associated with hill slopes and plateaus. Soil textures grade from loam at the surface, to loamy sands with depth; often containing rock material with little to no pedologic development throughout the solum. Vegetation associated with this unit includes *Eucalyptus crebra* and Bloodwood *Corymbia erythrophloia*.

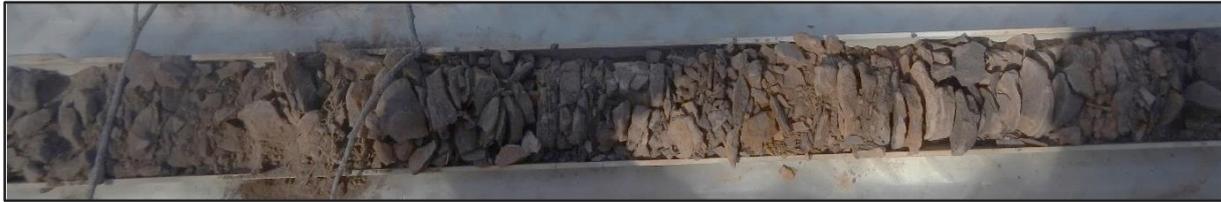
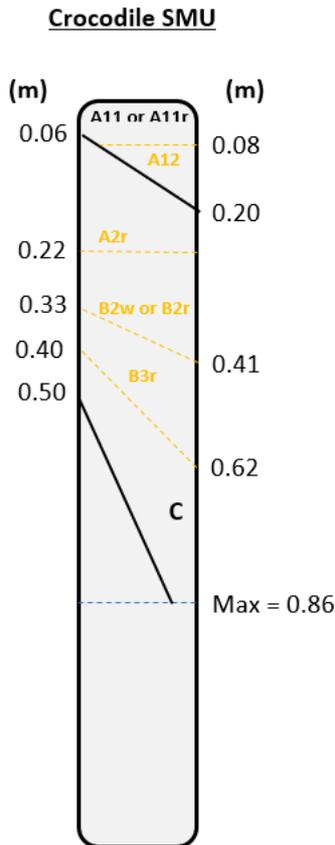
Profile description—representative sites VP5 and VP8

The **surface soil** (A11/A11r/A12) is a black to very dark greyish brown (10YR2/1, 10YR3/2) sand to sandy loam with loose to weak polyhedral structure with some profiles containing moderately strong to strong sub-angular rock material. The soil unit has a field pH of 4.5–5.5, demonstrating an abrupt to clear change to;

The **lower surface soil** (A2r) is not a common horizon observed for this SMU. It is a dark brown (10YR3/3) loamy sand with an abundance (comprising 50–90% of this horizon) of moderately strong coarse fragments approximately 2–6 cm in diameter. It has loose structure and a field pH of 5.5 to 5.0. Gradual change to;

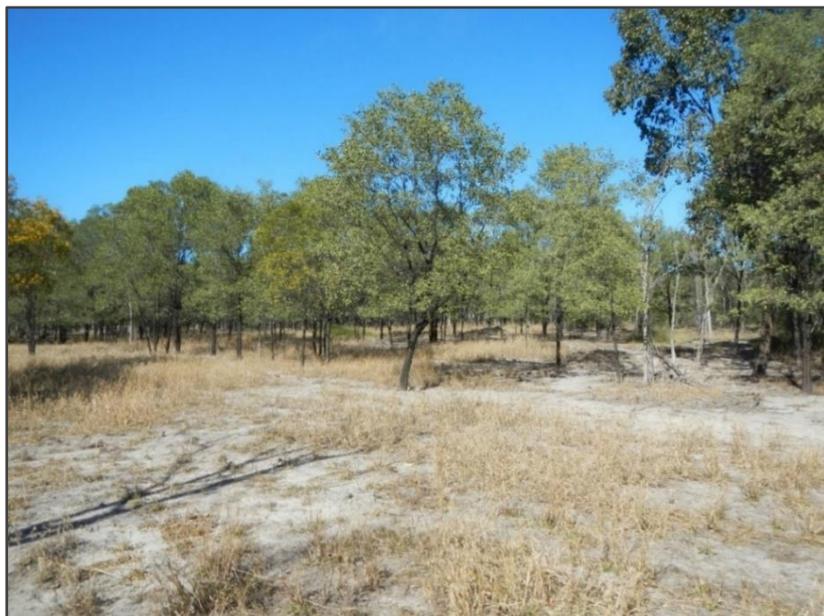
Figure 5: Fish SMU vegetation

Predominantly sandy soil unit occurring on the flats of the south-eastern end of the study area. Soil textures grade from loamy sand at the surface, to clay and silty sands with depth. Vegetation associated with this unit includes largely *Acacia excelsa* and *Eucalyptus populnea*.

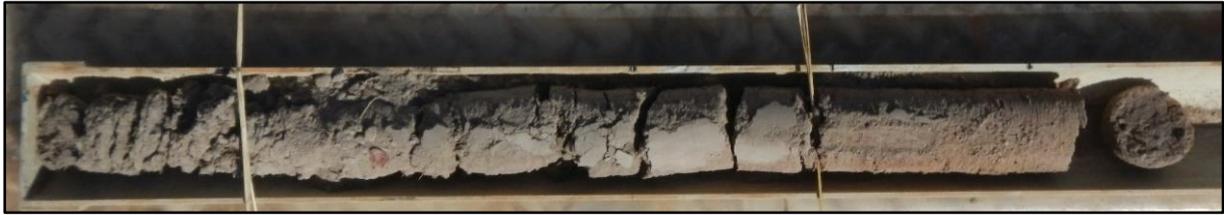
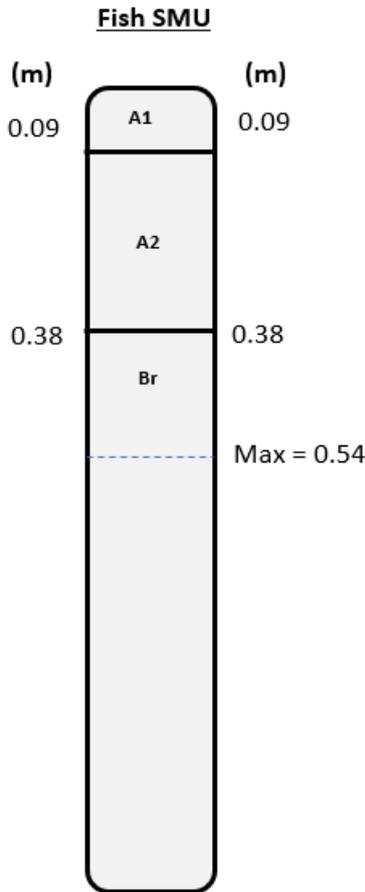
Profile description—representative sites VP27

The **surface soil** (A1) is a dark grey (10YR4/1) loamy sand with weak platy structure with the deeper horizons of the profile exhibiting diffuse red to orange mottling. It has a field pH of 5.5 to 6, demonstrating a clear change to;

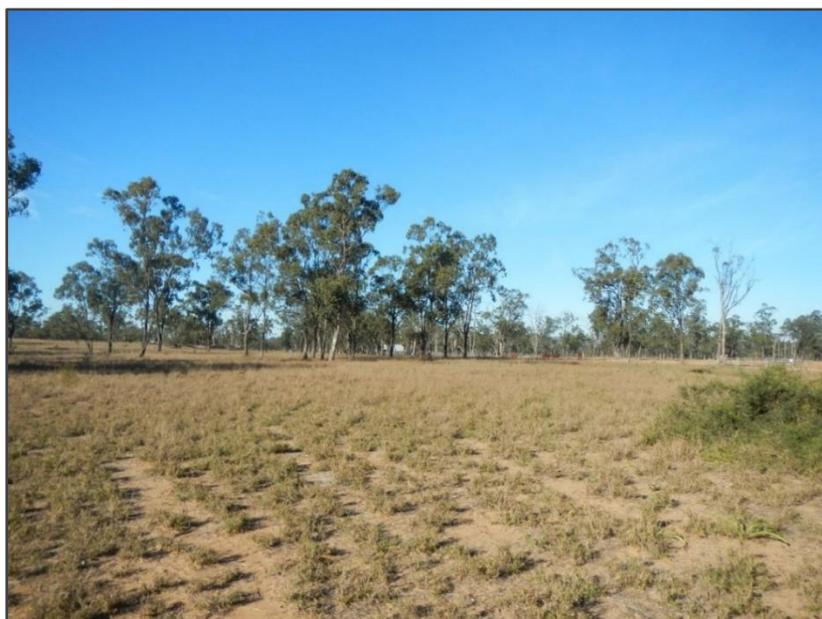
Figure 6: Kei SMU vegetation

Brown coloured soil unit occurring on the flats of the south-eastern end of the study area. Soil textures grade from clayey to loamy sands at the surface, to medium clay with depth and orange to yellow mottles present in the deeper horizons. Vegetation associated with this unit largely includes *Eucalyptus populnea*.

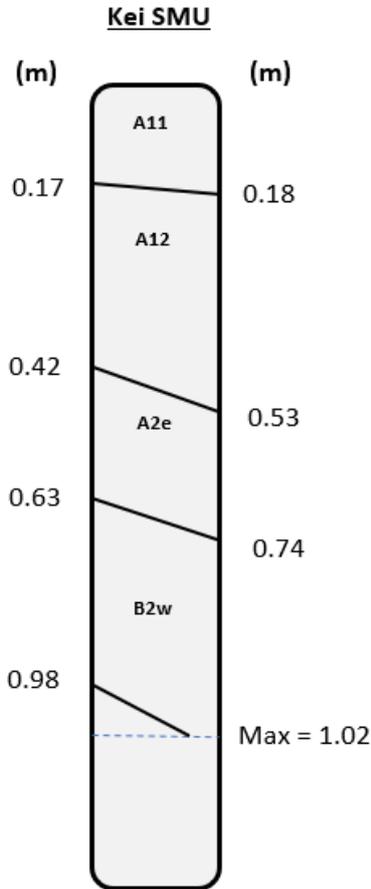
Profile description—representative sites VP26 and VP30

The **surface soil** (A11/A12) is a very dark greyish brown to dark yellowish brown (7.5YR3/2, 7.5YR3/4) clayey sand to sandy loam with a loose to weak platy structure. It has a field pH of 6 to 7, demonstrating a gradual to diffuse change to;

The **lower surface soil** (A2e) is a bleached brown (10YR4/4) loamy sand. This horizon has a loose structure and a field pH of 7–7.5. Clear to gradual change to;

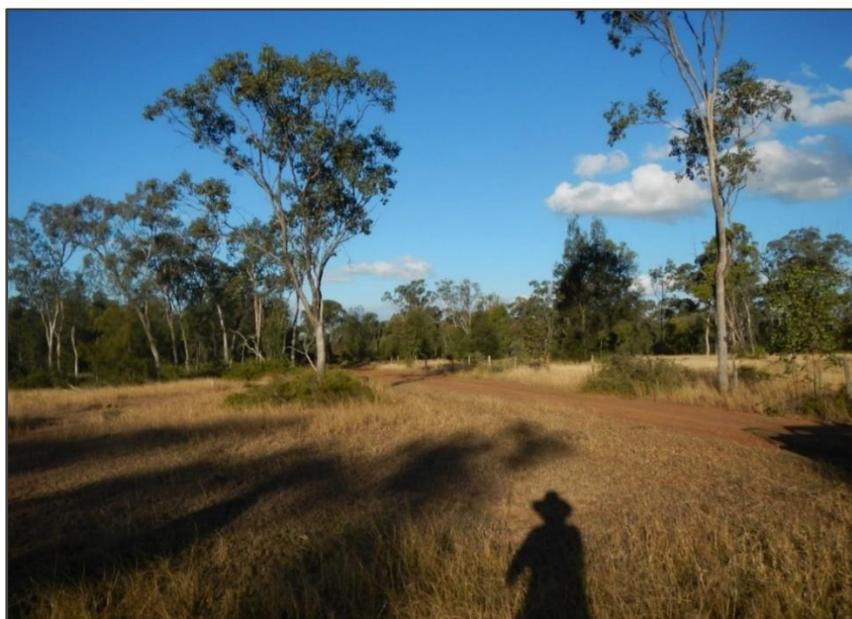
Figure 7: Komati SMU vegetation

Dark brown coloured soil unit displaying vertic properties. Soil textures predominantly grade from light to medium clays with calcareous segregations occurring within the deeper horizons. Vegetation associated with this unit includes *Eucalyptus papuana* and open grassland.

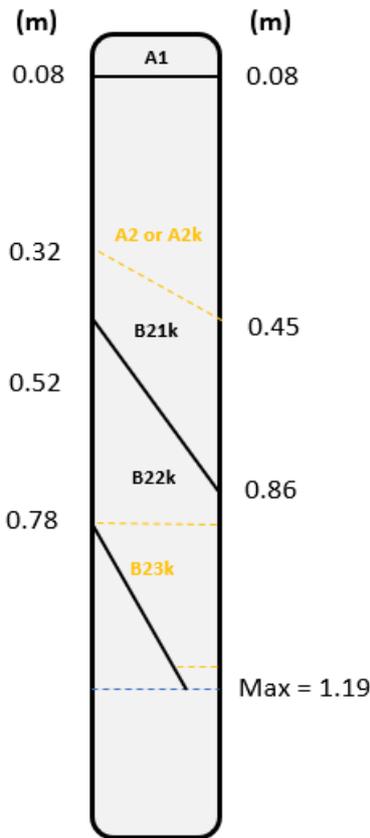
Komati SMU

The **surface soil** (A1) is black to a very dark brown (7.5YR2.5/1, 7.5YR3/3) sandy clay loam to light medium clay with a polyhedral structure of moderate strength. It has a field pH of 7-8.5, demonstrating a clear to abrupt change to;

The **lower surface soil** (A2 or A2k) this horizon was not observed in all profiles of this SMU. It is a brown to very dark brown (7.5YR4/4, 10YR2/2) light medium to medium clay with a moderately strong polyhedral structure and a field pH of 8–8.5. Some profiles display a minor occurrence (< 10%) of calcareous segregations. Clear to gradual change to;

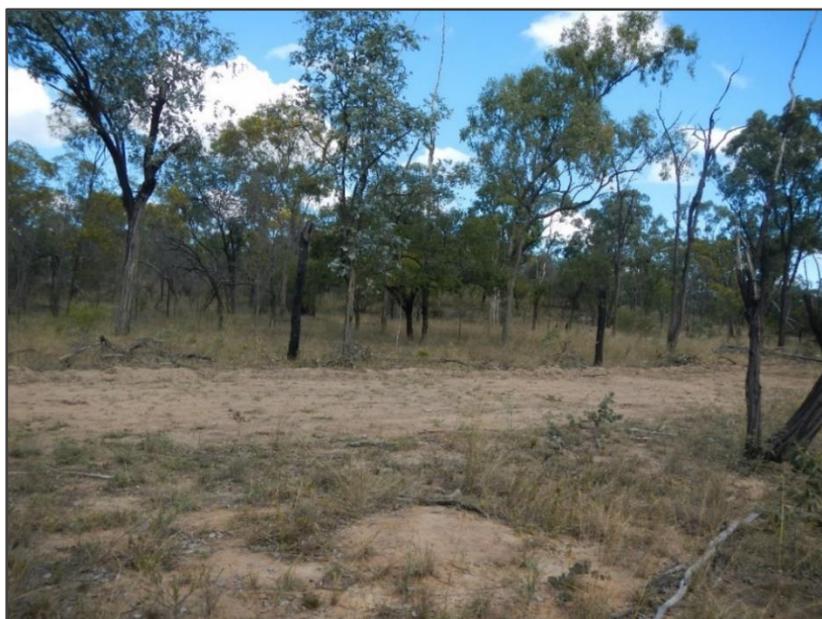
Figure 8: Limpopo SMU vegetation

The Limpopo unit is a brown texture-contrast soil. Soil textures predominantly grade from sands to clay sands in the surface soils to light clays in deeper horizons. Vegetation associated with this unit includes *Eucalyptus populnea* and *Eucalyptus crebra*.

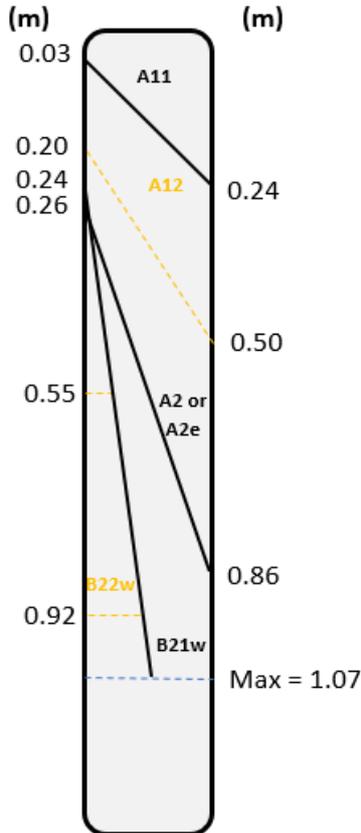
Limpopo SMU

The **surface soil** (A11, A12) is brown to a dark brown (7.5YR4/4, 7.5YR3/3) sand to loamy sand with a loose structure. It has a field pH that ranges between 5 and 6, demonstrating a clear to gradual change to;

The **lower surface soil** (A2 or A2e) is a brown to greyish brown (7.5YR4/4, 10YR5/2) with some profiles within this soil unit displaying bleaching in this horizon (A2e). Predominant textures observed in this horizon range from sandy loams to sandy clay loams with a loose to weak polyhedral structure and a field pH of 6. Clear to gradual change to;

The **subsoil** (B21w, B22w) includes dark yellowish brown to a dark greyish brown (10YR4/4, 10YR4/2) clayey or sandy loams and light clays clay with weak to moderate strength polyhedral structure. Mottling was often observed in this horizon with colours ranging between red, orange and yellow. This horizon has a field pH of 5.5-7.

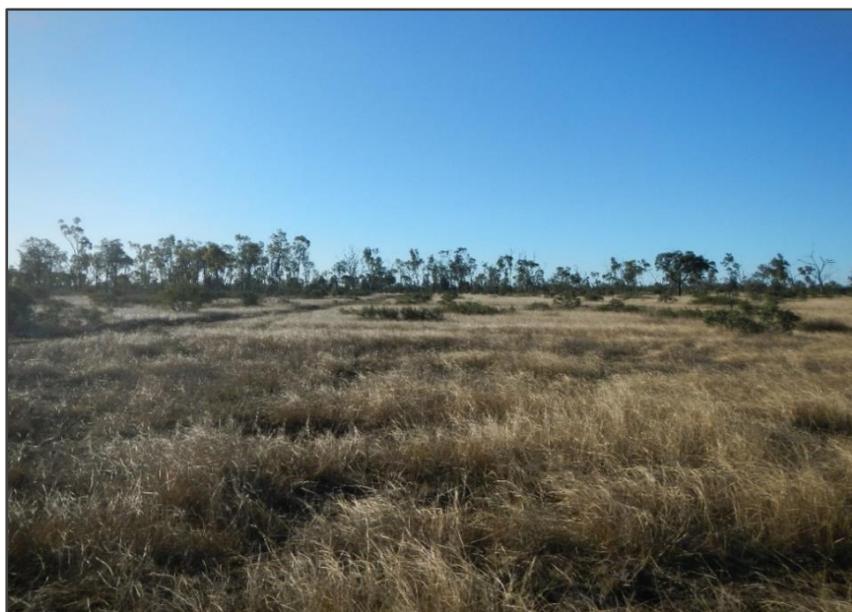
Figure 9: Orange SMU vegetation

Dark cracking clays associated with the flat grassy plains of the mid-eastern edge of the study area. The predominant textures of soils within this unit range from light clays in surface soils to light medium clays in deeper horizons. Vegetation associated with this unit is predominantly open grassland.

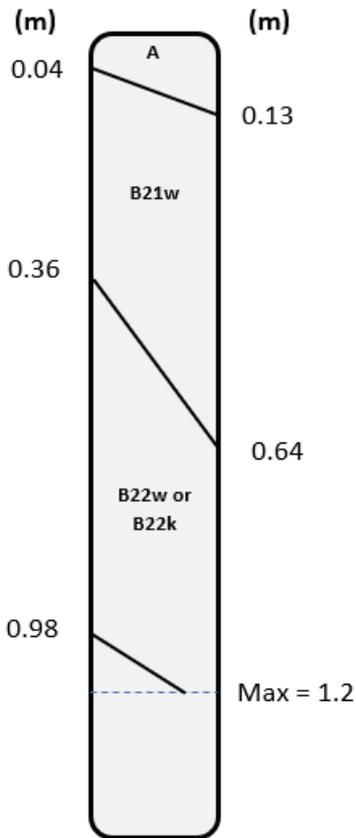
Orange SMU

The **surface soil (A)** is black (10YR2/1, 2.5Y2.5/1) light clay with moderate lenticular structure. It has a field pH of 6–7, demonstrating an abrupt change to;

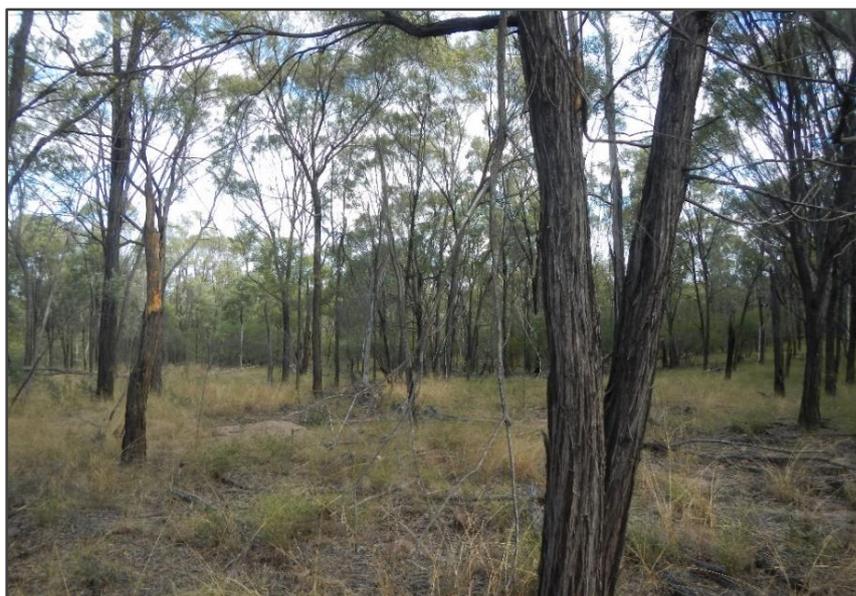
Figure 10: Sabie SMU vegetation

A dark-coloured texture-contrast soil with surface soils consisting of sands, increasing in clay content in deeper horizons. Lower horizons display red to orange mottles. Vegetation associated with this unit is dominated by *Eucalyptus crebra*.

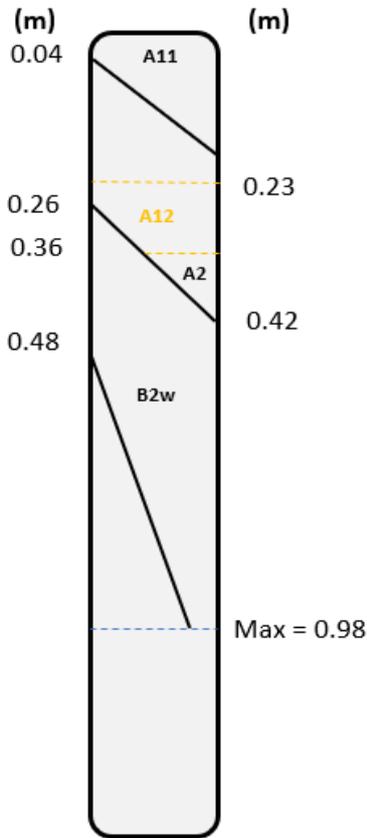
Sabie SMU

The **surface soil** (A11/A12) is black to very dark brown (2.5YR2.5/1, 7.5YR2.3/3) sand to loamy sand with loose to very weak platy structure. It has a field pH of 5–7, demonstrating a clear to abrupt change to;

The **lower surface soil** (A2) is a brown to a dark reddish brown (7.5YR4/4, 5YR3/3) clayey sand to sandy clay loam with loose or very weak polyhedral structure and a field pH of 5–6. Clear to gradual change to;

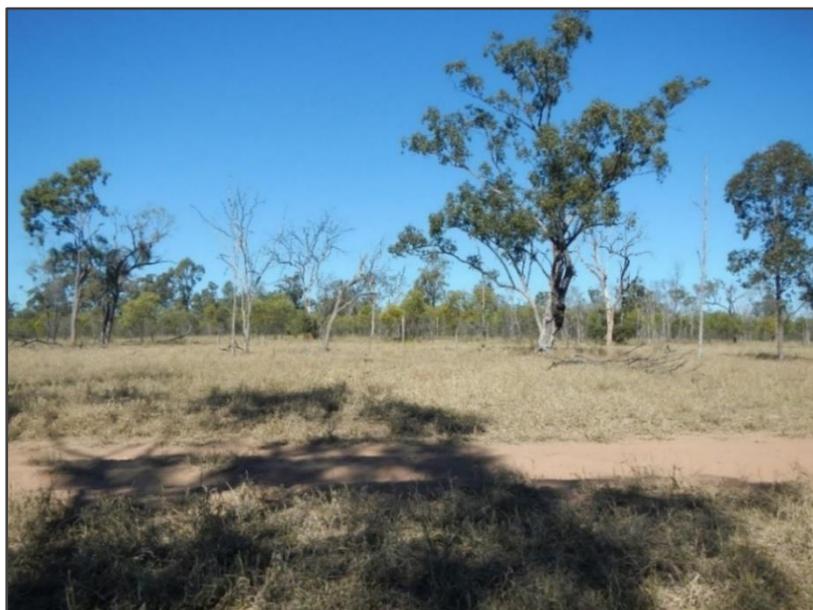
Figure 11: Zambezi SMU vegetation

A predominantly grey coloured texture-contrast soil with surface soils consisting of sands, increasing in clay content in deeper horizons. Lower horizons display diffuse orange to yellow mottles. Vegetation associated with this unit is dominated by *Eucalyptus populnea*.

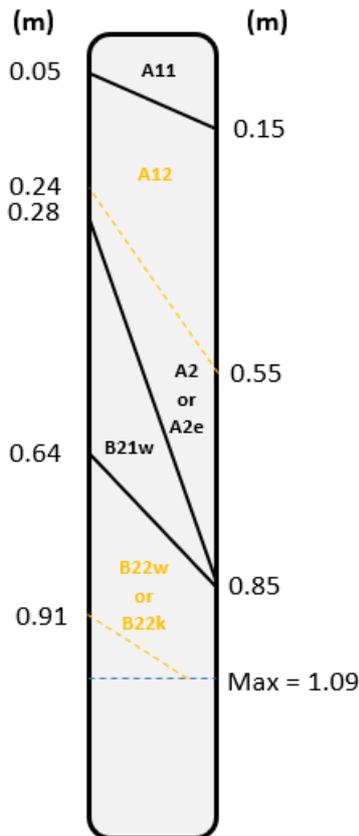
Zambezi SMU

The **surface soil** (A11/A12) is dark brown to a very dark greyish brown (7.5YR2.2.5/5, 10YR3/2) coarse grained loamy sand with loose to very weak platy structure. It has a field pH of 5.5–7, demonstrating a clear to abrupt change to;

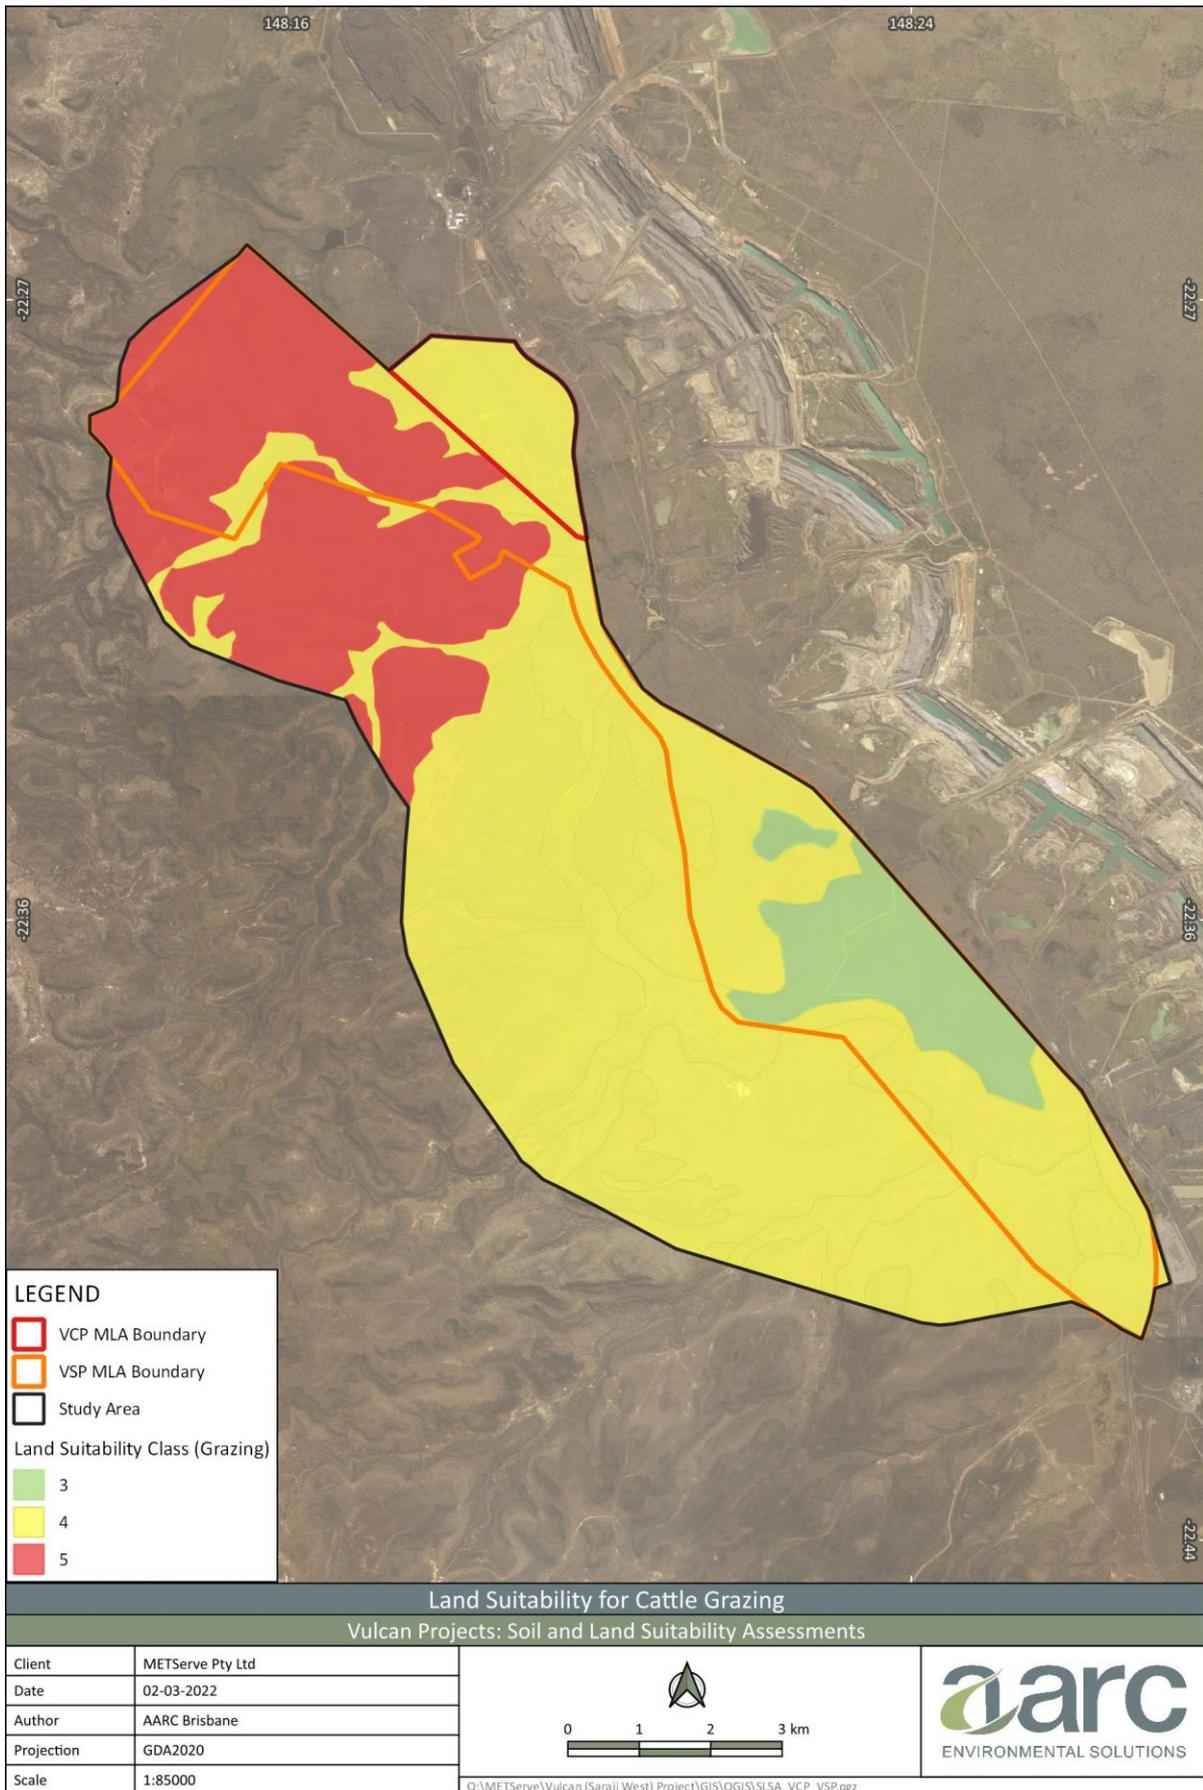
Figure 12: Cattle grazing land suitability classes

Notes: Green shading = suitable, red shading = unsuitable.

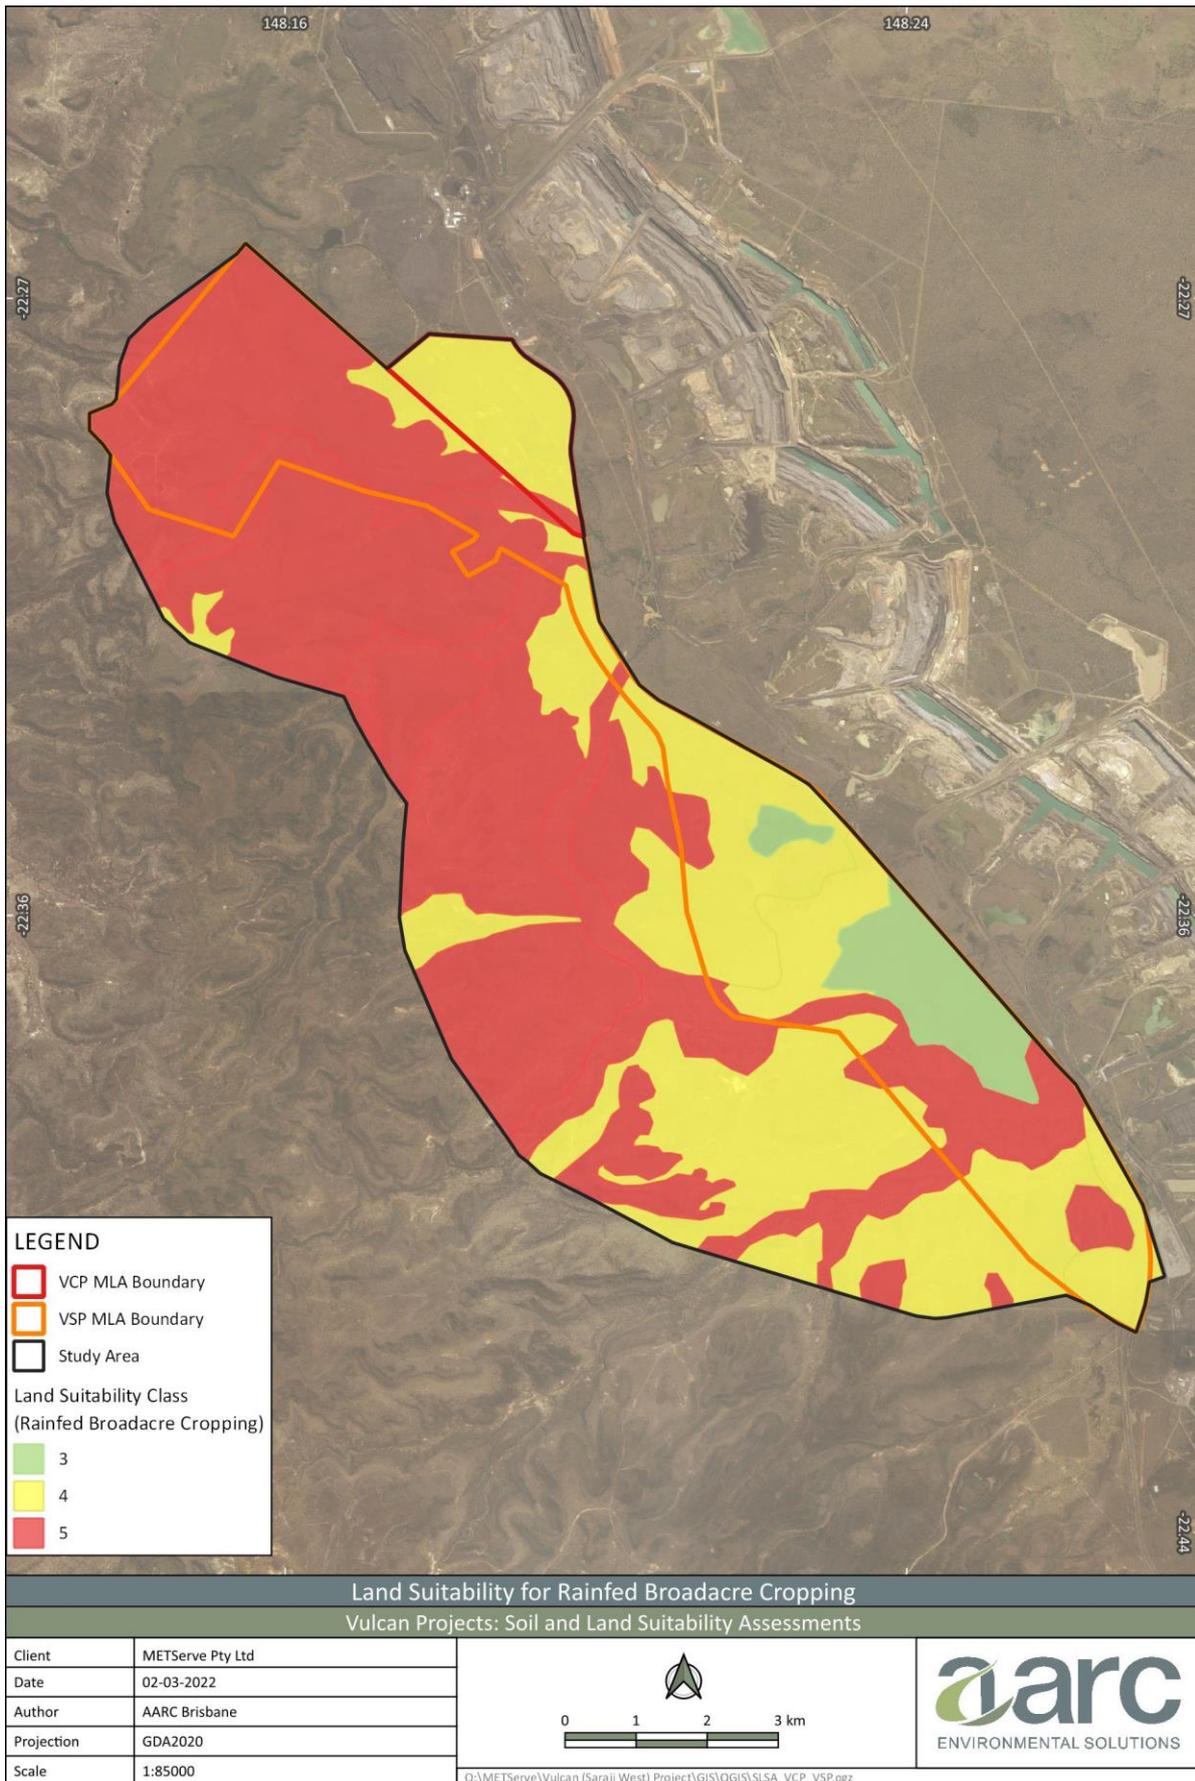
Figure 13: Rainfed broadacre cropping land suitability classes

Notes: Green shading = suitable, red shading = unsuitable.
