**PROGRESSIVE REHABILITATION
AND CLOSURE PLAN
VULCAN SOUTH
Tenure number: MLA 700073**

Prepared for: Department of Environment and Science

Prepared by: Mining and Energy Technical Services Pty Ltd

EA holder: Vitrinite Pty Ltd

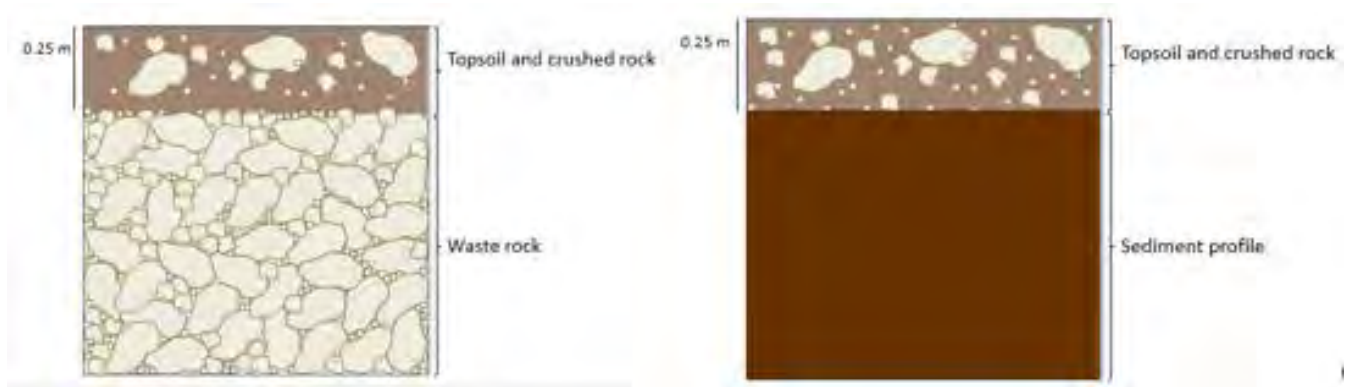
Figure 6-5 Highwall mining area cover design strategy for ex-pit WRD (left) and remaining areas (right)

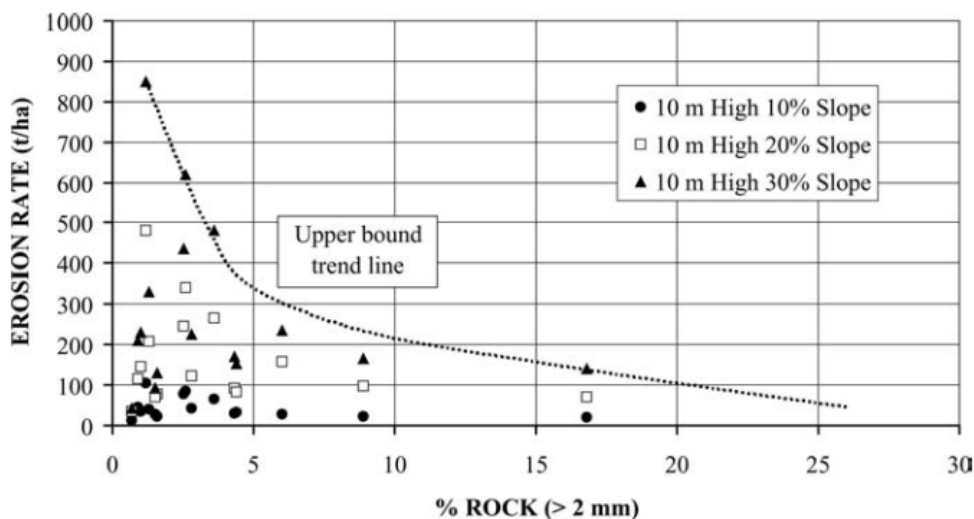
Figure 6-15 Erosion rate versus percentage rock for Bowen Basin soil materials (Williams, 2001)

Studies in Queensland demonstrated that any gradient exceeding 3.5%, if not protected by some sort of cover, will erode under average rainfall conditions, and extreme rainfall can erode bare slopes greater than 0.35% (Williams 2001). However, rock or vegetation cover drastically reduces erosion rates (**Figure 6-15**).
